REPLACING THE SEAL.

MAINTENANCE

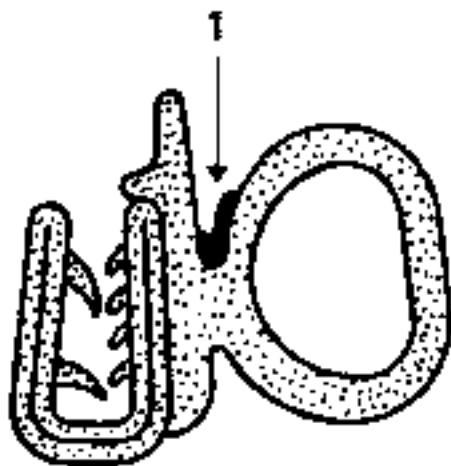
M11046

- 1 Front righthand door frame seal
- 2 Front lefthand door frame seal
- 3 Rear righthand door frame seal
- 4 Rear lefthand door frame seal
- 5 Tailgate frame seal

The door aperture protection must be removed in order to remove the door seals.

When refitting the parts, it is essential to respect the position of the spot of paint (1) in the corners marked (A) and (B).

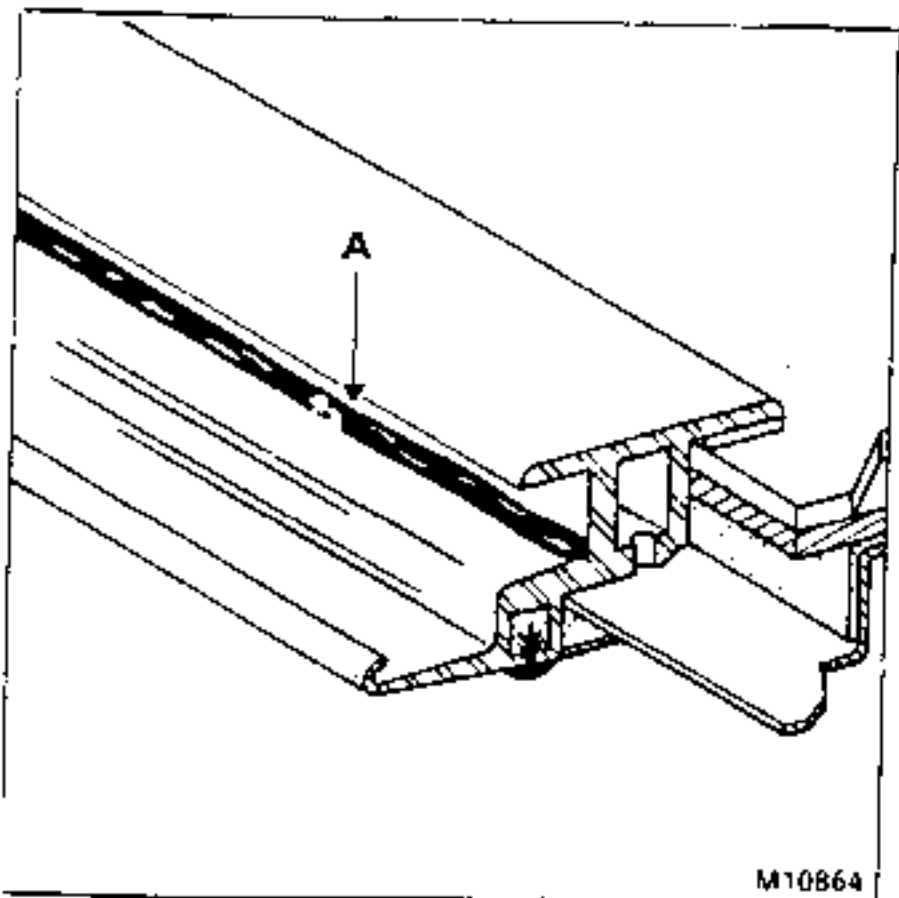
Use the tube supplied with the seal to extrude an even bead (A), 3mm in diameter, around the edge of the frame.

Cover the screws appearing under the seal with a thin layer of mastic.

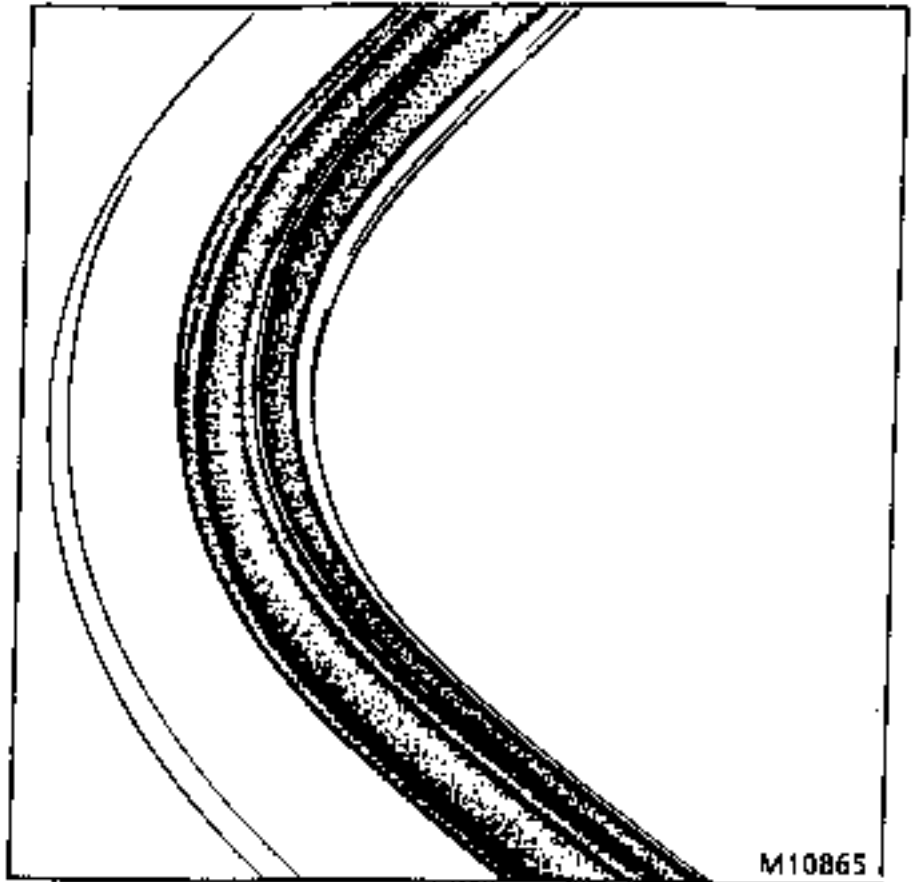
Fit the new seal: the join at the rear must be on the centre line of the opening handle.

NOTE: the seal should not slant towards the inside in the corners; if it does, the seal is too compressed. It must be partially removed again.

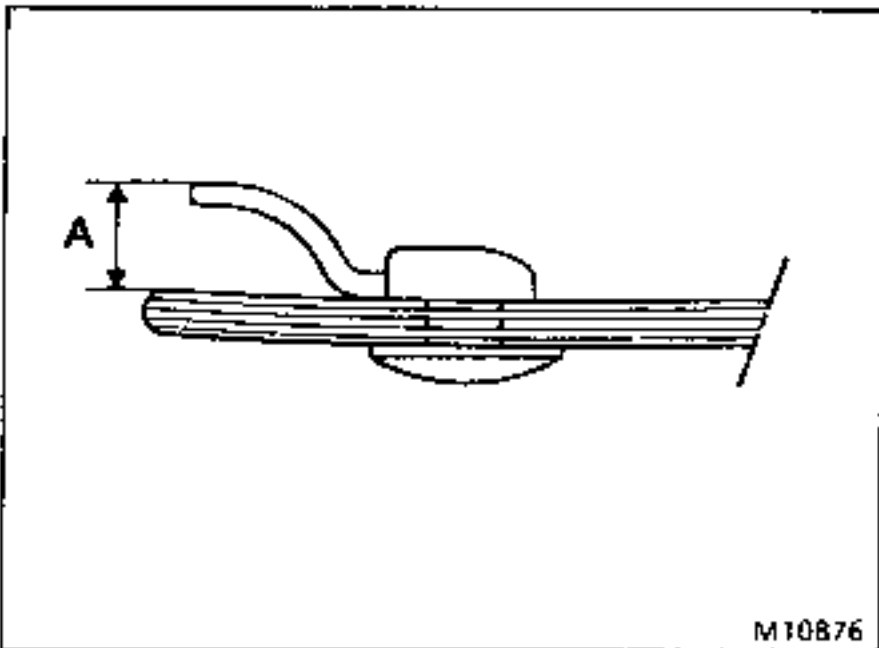
- glass front lugs deformed
dimension A = 22mm (correct if necessary).

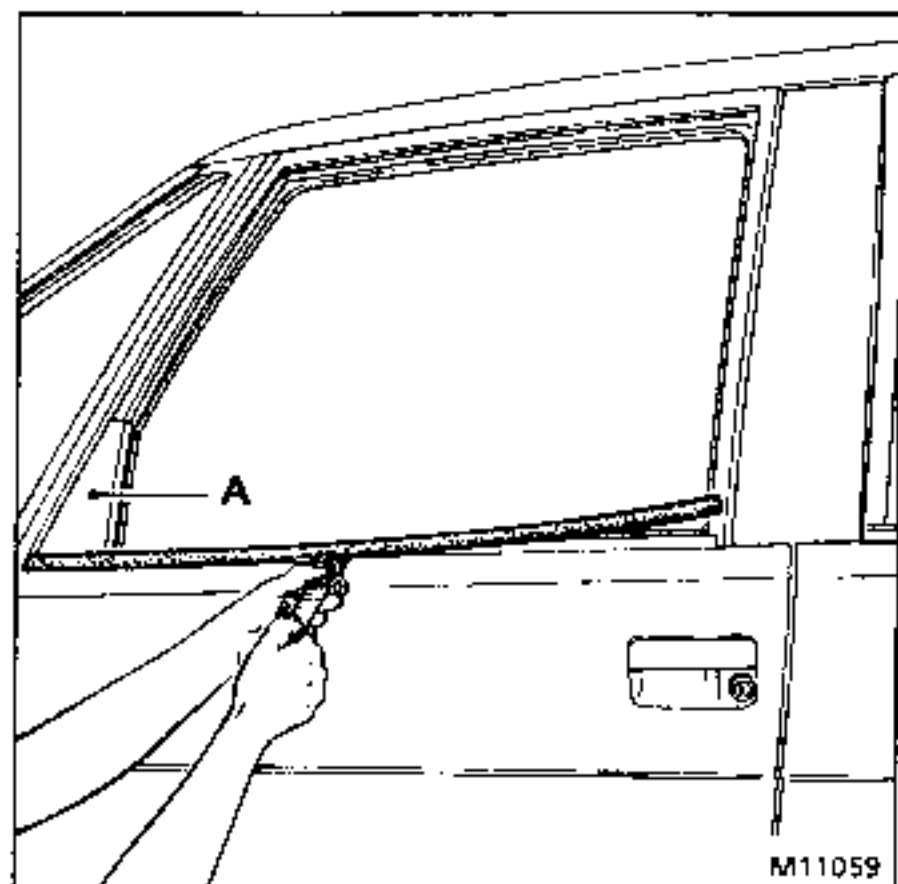
Remove outer triangle (A) by unsticking
it from the upper corner using a spatula
with a sharp edge.

ATTENTION: as the rubbing strip is
a fragile part, raise it every 10cm
using a wooden spatula protected by
a piece of cloth.

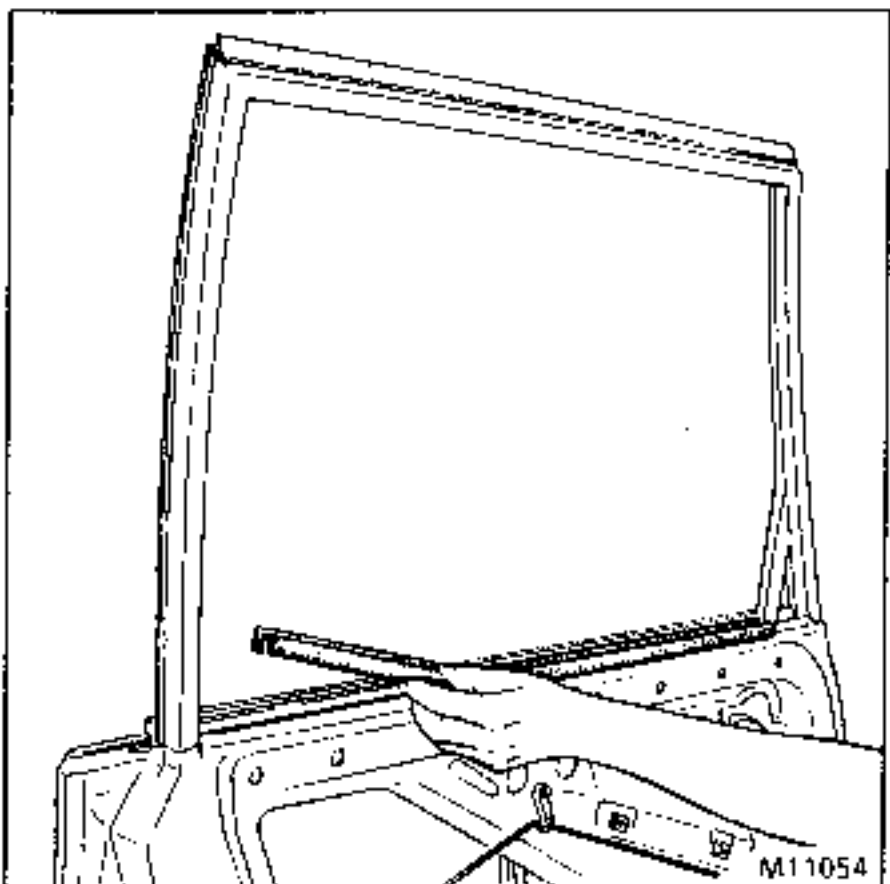
Front door inner rubbing strip

Remove the inner trim (section 72).

Raise the rubbing strip manually.

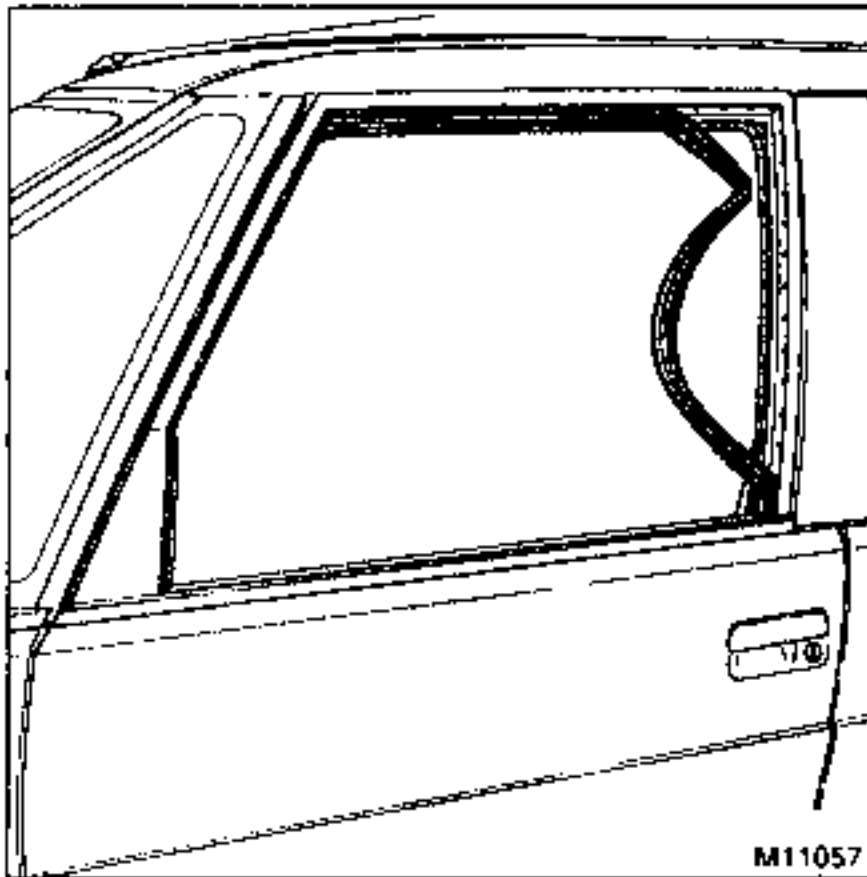
- the window and inner trim;
- the frame slide channel starting at the rear vertical section.

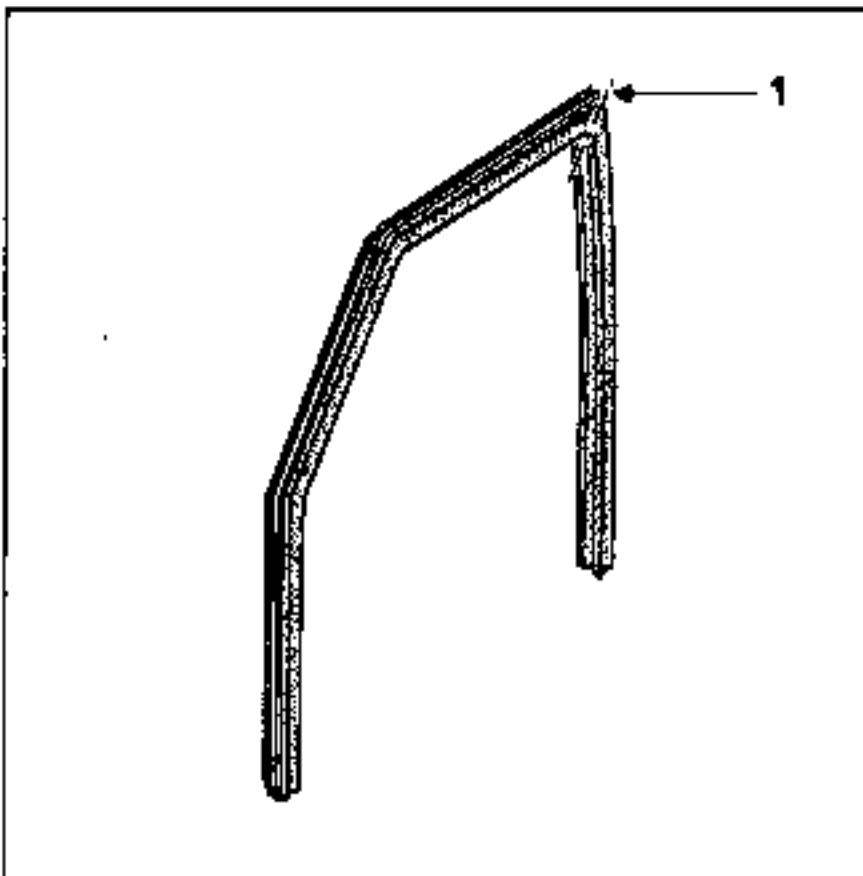
Refitting

Start at upper corner (1).

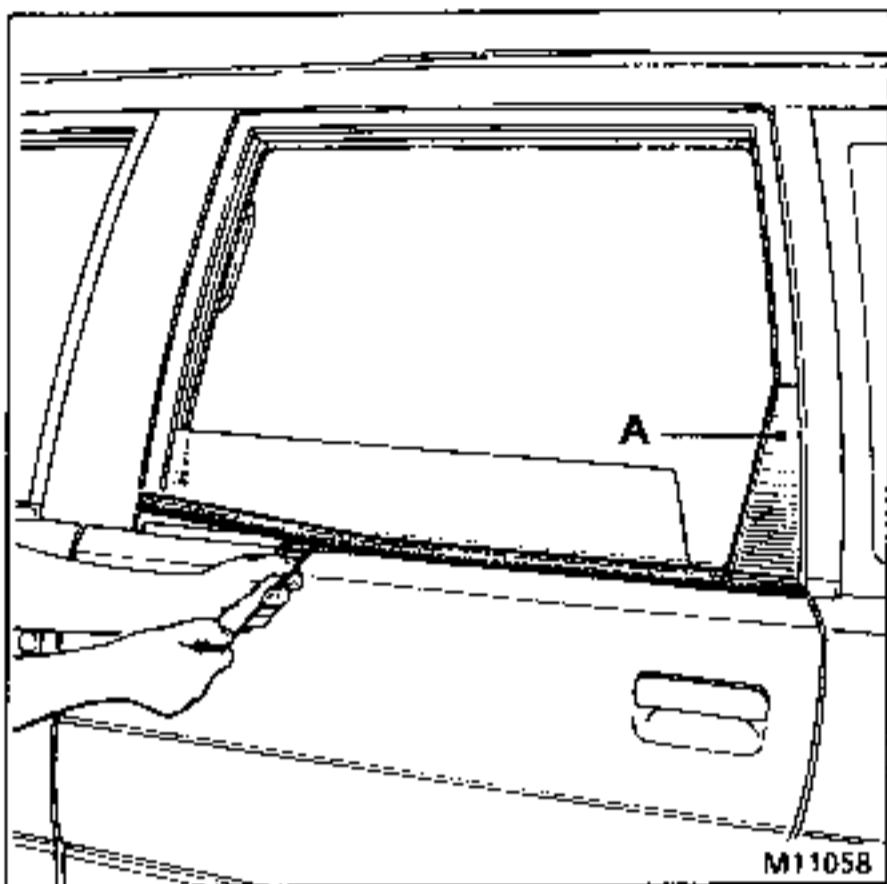
Remove moulding (A) by unsticking it from
the upper corner using a spatula with
a sharp edge.

ATTENTION: as the rubbing strip is a
fragile part, raise it every 10cm with
a wooden spatula protected by a piece
of cloth.

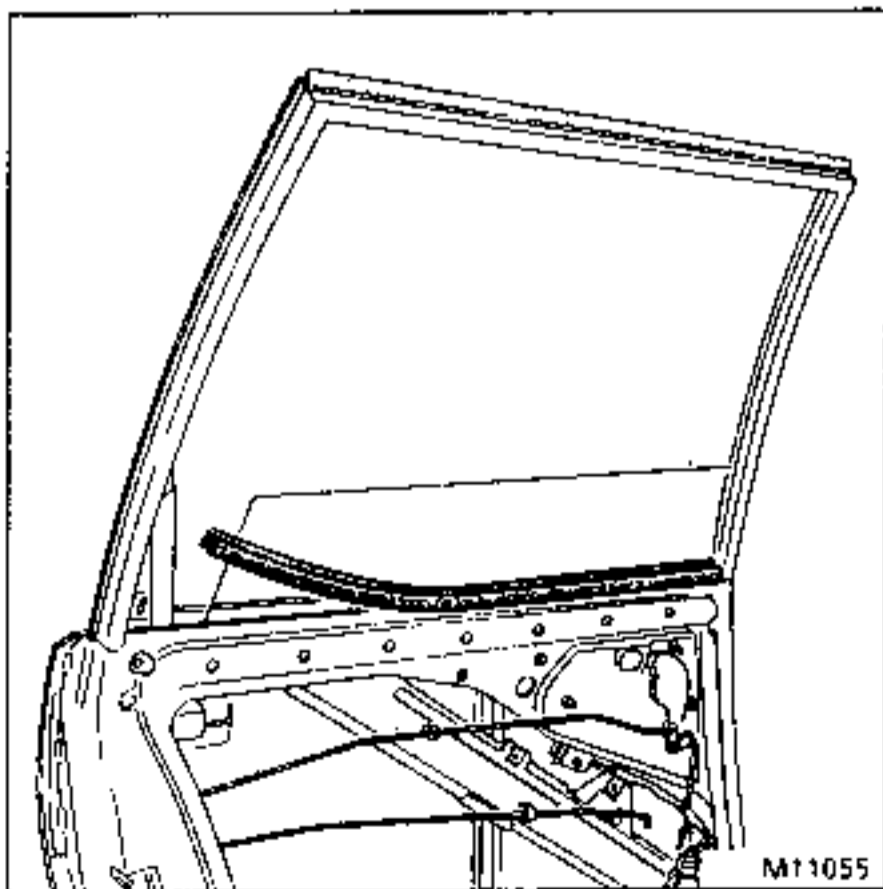
Rear door inner rubbing strip

Remove the inner trim (see section 72).

Raise the rubbing strip manually.

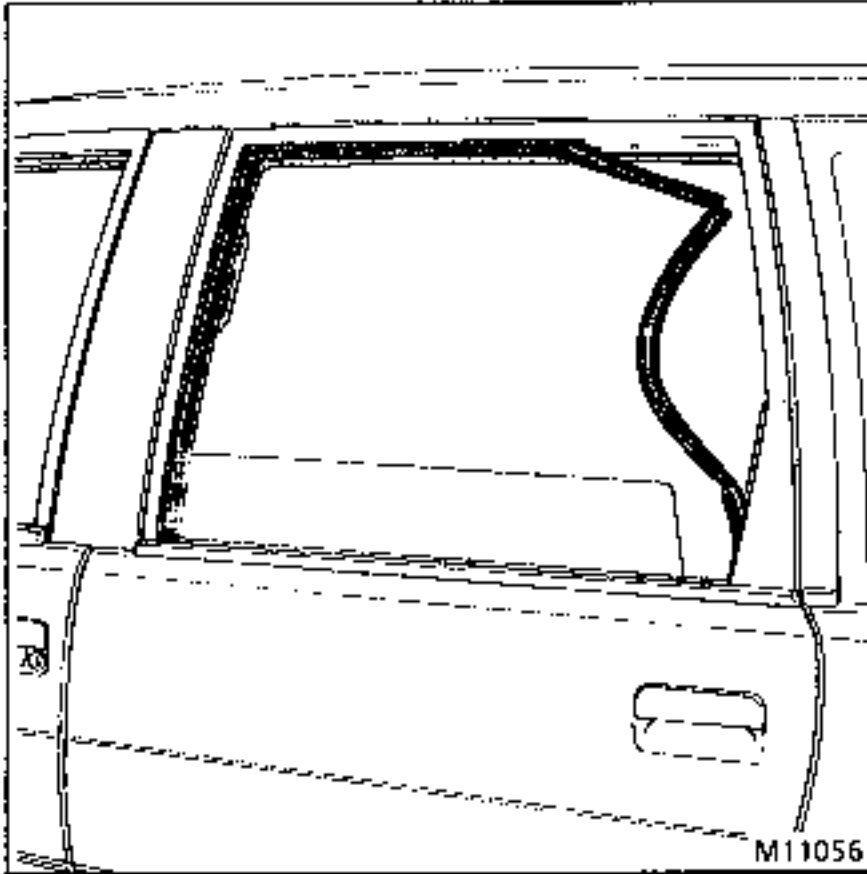
- the window and inner trim;
- the frame slide channel starting at the rear vertical section.

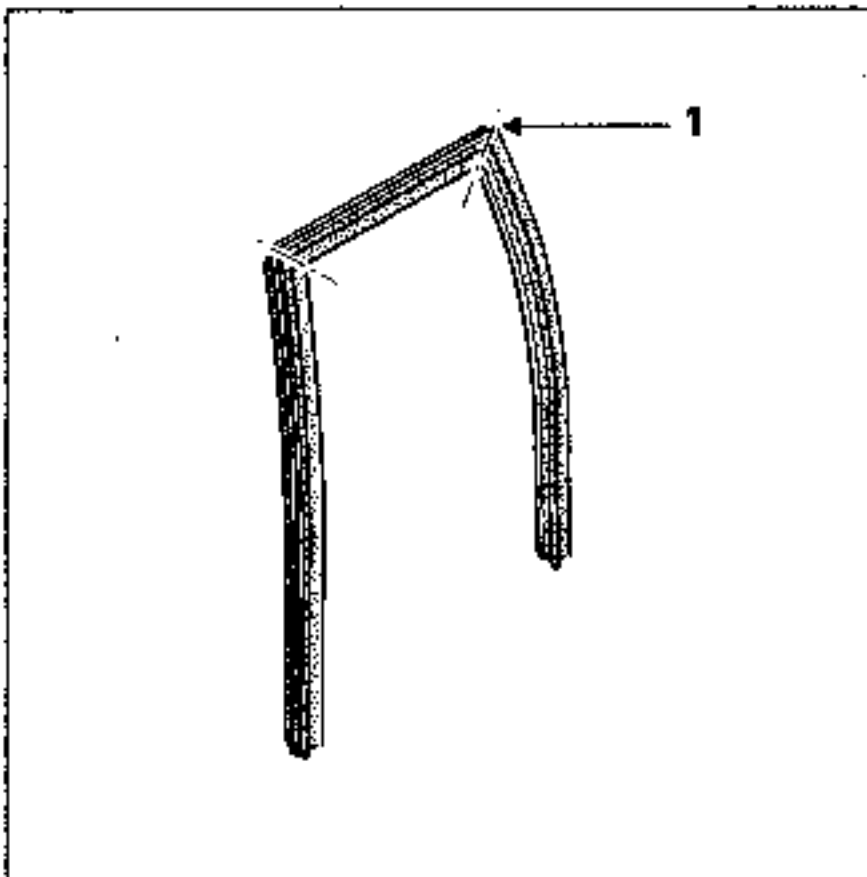
REFITTING

Start at upper corner (1).
